HOW THEY BUILT IT

A Salute to Outer Beauty

This design-build team had to deal with the challenge of gutting an entire exterior of a home in Oakton, Va.

Winn Design + Build

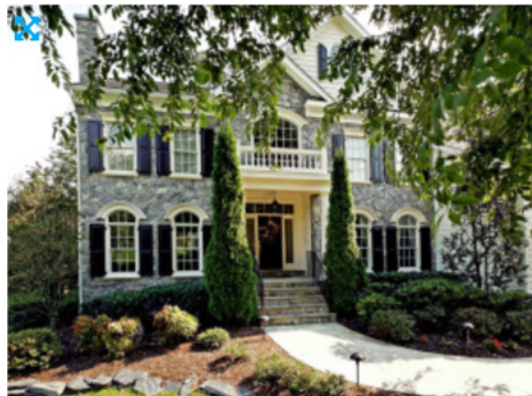
To update the exterior of this home, [Michael Winn and his team](#) had to start with a complete gut job in Oakton, Va. The house had an Exterior Insulated Finish System (EIFS), designed to be water-resistant and block moisture, but a home inspection revealed that moisture and water damage actually were being made worse by the EIFS. The homeowner then brought in Winn and his team to remediate the damage.

“Once it was determined the scope of the damage was such that it couldn’t really be mitigated or repaired in any effective way, the decision was just to get rid of it all together,” Winn says. “We essentially re-skinned the entirety of the home.”

The complete stripping of the home’s exterior then allowed the team to play with a blank canvas, replacing the plywood sheeting with fiber cement siding and stone to give the home fresh architectural appeal. Winn also replaced the existing windows and added a new window to the front of the house. The result was a dramatic before-and-after transformation that adds significant curb appeal.
